PROJECT OVERVIEW

PROJECT DETAILS

Location: Cheektowaga, NY

Application: Manhole Rehabilitation

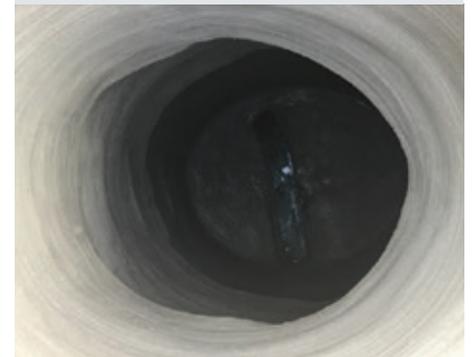
Completed manhole rehabilitation.

GeoSpray mortar went on quickly and easily and did not crack. The township was pleased with the pilot application and specified GeoSpray mortar on a 5000 vertical linear foot manhole 2018 project, which NWMCC will install this summer.

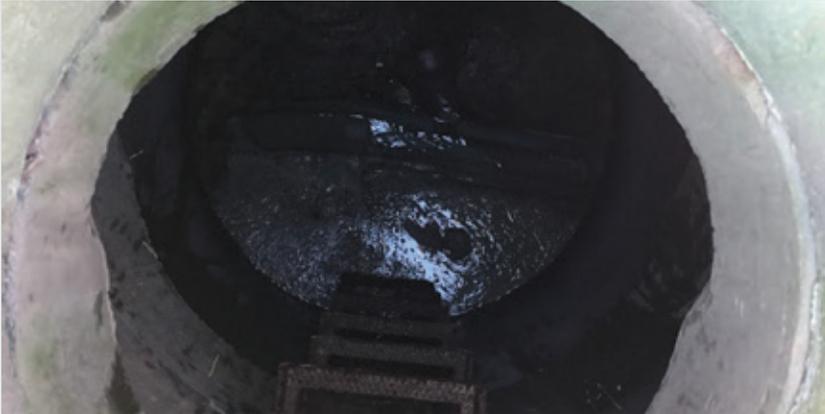
Concrete manhole prior to rehabilitation.

The town engineer decided to test out a pilot study with a truckload of GeoSpray geopolymer mortar to line about 700 vertical linear feet. MIS provided technical assistance to the township and the installation contractor National Water Main Cleaning Company (NWMCC) powerwashed the manhole, mixed the GeoSpray mortar and pumped it down into the hole to apply it with a handheld spray nozzle.

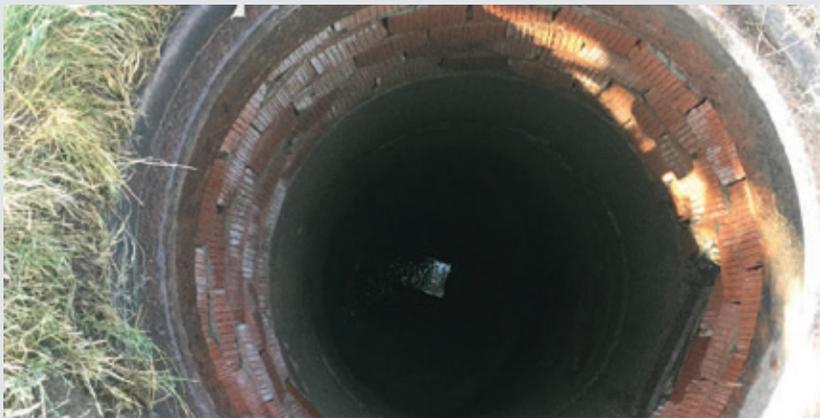
Brick manhole prior to rehabilitation.

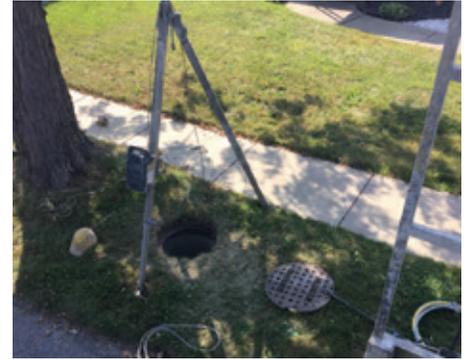
Typical manhole application in right-of-way with tripod set up.

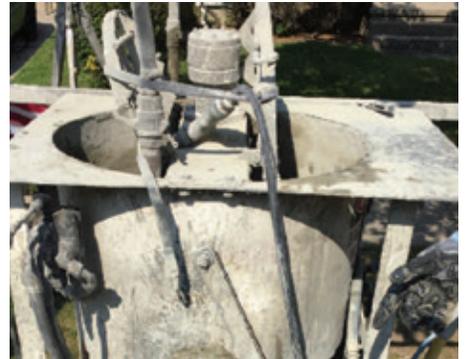
GeoSpray mixed and prepared to send for application.

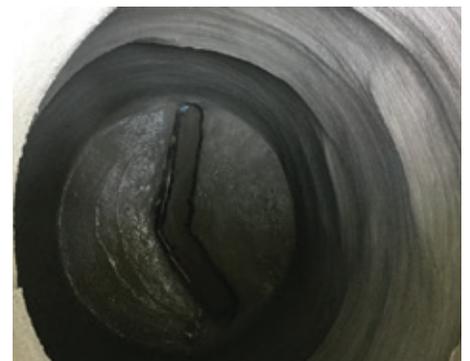
Completed manhole rehabilitation.
