PROJECT OVERVIEW

GEO SPRAY[®]

Geopolymer Mortar

CASE STUDY: Washington, D.C. Manhole Rehabilitation

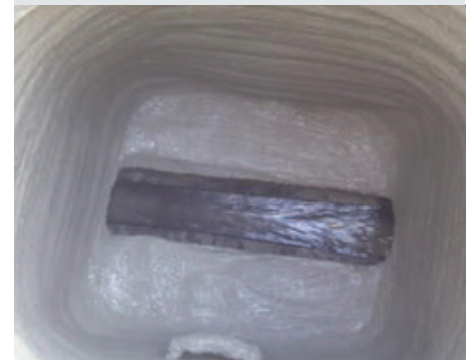
Like-new manhole and bench after GeoSpray mortar application.

The GeoSpray mortar was applied using a vertical centrifugal spinning system. Voids in the brick manholes were first repaired with a hydraulic cement. Where necessary, a chemical grout was first injected to stop any running water infiltration through the voids. A 1" (25mm) thick application was applied to create a structural repair.

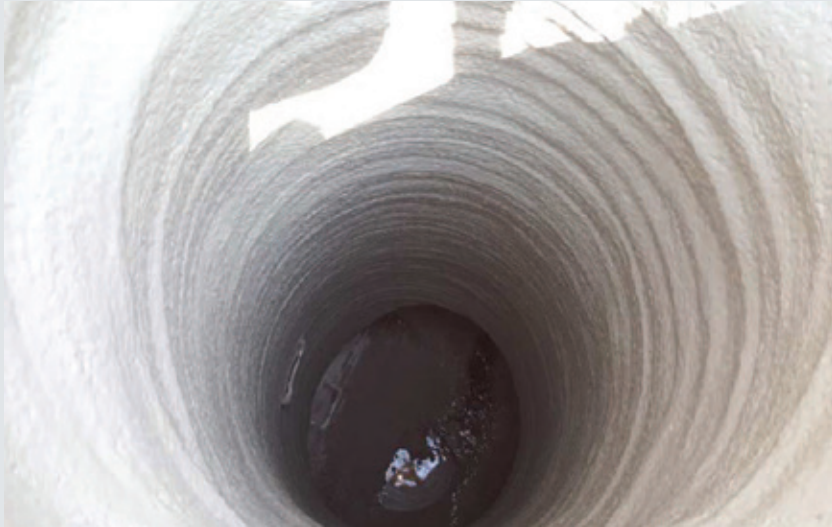
Completed manhole.

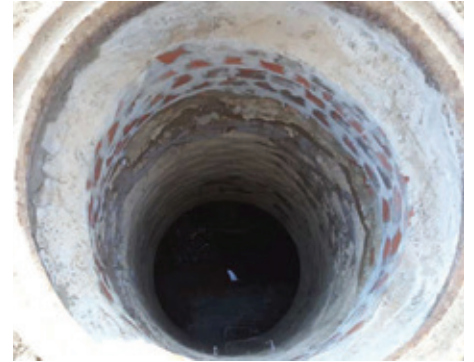
The 72" (1830mm) diameter manholes to be repaired were brick and had suffered deterioration, resulting in cracked and missing mortar, leaks and water infiltration, and several were in structural distress.

Manhole prior to spraying.

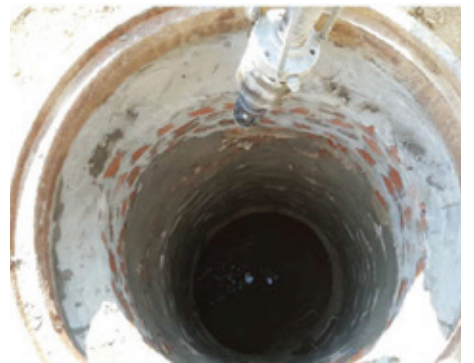
Start of GeoSpray mortar application.
