# GEO SPRAY<sup>®</sup>

## Geopolymer Mortar

### CASE STUDY:

## RCP Sanitary Sewer Houston, TX

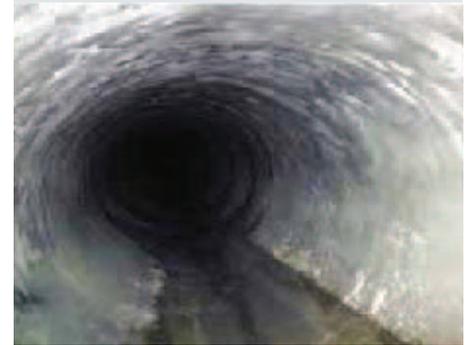
Sanitary sewer after one pass of GeoSpray mortar.

A bypass system consisting of two 16-inch HDPE pipes was constructed to control and divert the flow around the damaged pipe section. The pipe was then inspected by CCTV to provide the asset owner an assessment of the existing conditions. Once the assessment was completed, major infiltration was stopped using a chemical grout. The GeoSpray lining operation took a total of four days, and the entire project was conducted over a period of 11 days. A two-inch thick coating was sprayed along the entire 160-foot section over the course of the first three spraying days, and then an additional one-inch coating was sprayed the entire length of the pipe on the final spraying day. The resulting pipe was then sprayed with the GeoSpray AMS post-coat solution to enhance the already highly chemical resistant liner.

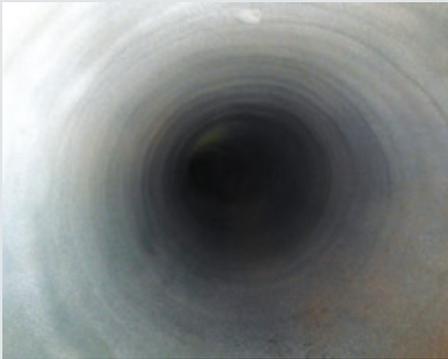
Sanitary sewer after completed GeoSpray mortar application.

The pipe was put back into service one day after the final spraying of GeoSpray AMS post-coat. The city of Houston continues to use GeoSpray as the preferred cost effective solution for repair of its large diameter sewer pipes.

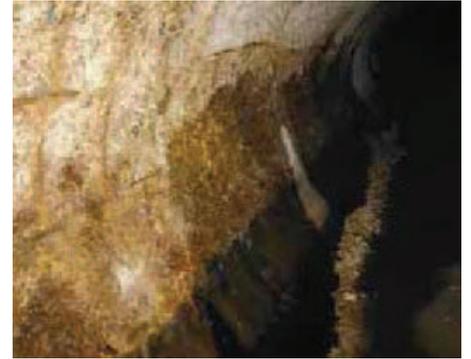
One such section of pipe, approximately 165 linear feet in length and 60 inches in diameter, terminates at the Northwest Wastewater Treatment Plant (WWTP) and runs 25 feet directly below the White Oak Bayou. The pipe was in extremely poor condition with exposed rebar for most of the length and several locations with gushing water infiltration.

Water infiltration in several locations.

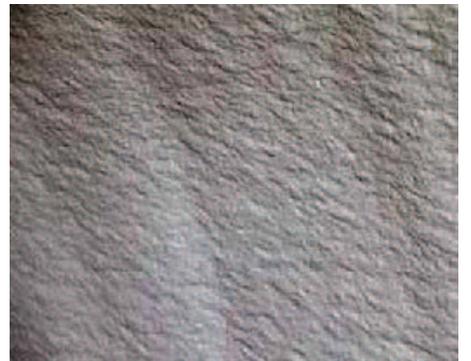
Close-up of sanitary sewer after GeoSpray application.

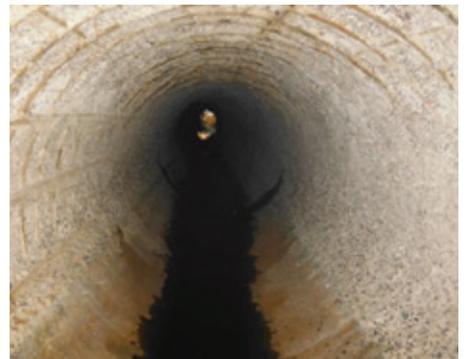
Sanitary sewer after initial pass.
