AVT™ EZ VALVE®

PVC Line Returns to Service

CASE STUDY: United Utilities, UK

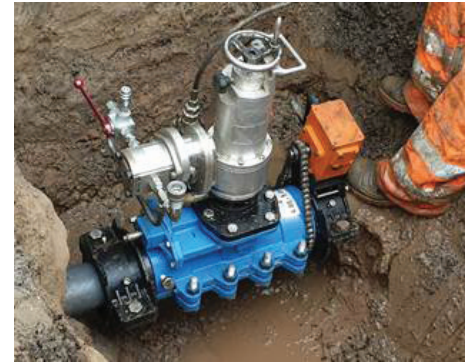
Three technicians installed the 4-inch (100-mm) AVT EZ Valve on a PVC clean water main in 3 hours, delivering a durable solution without interrupting service.

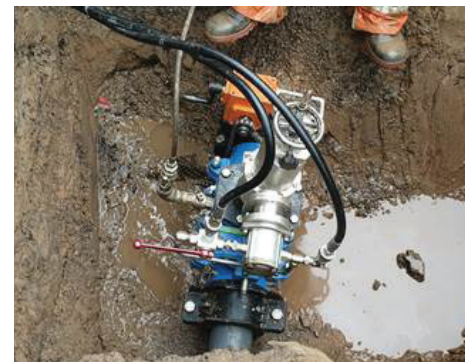
Using the newly installed left close, 4-inch (100-mm) AVT EZ Valve will make future maintenance less intrusive, less complicated, and less expensive.

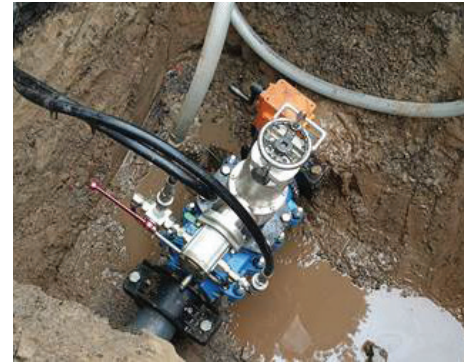
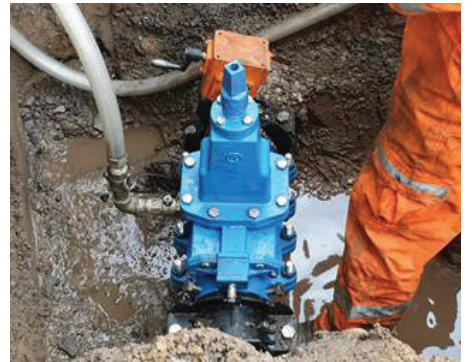
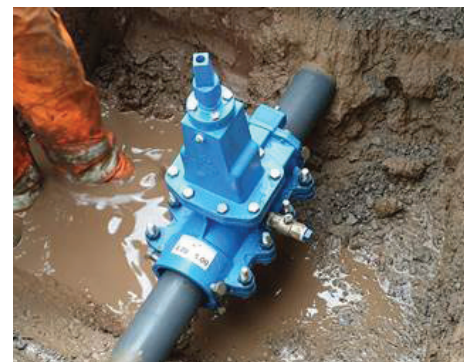
Using the 4-inch (100-mm) AVT EZ Valve allowed the utility company to continue service to approximately 2,000 customers during the repair, and using the newly installed valve will make future maintenance less intrusive, less complicated, and less expensive.

A trained 3-man installation team from R2M Site Services excavated the area and installed the AVT EZ Valve in only 3 hours, providing a durable and cost-effective solution that will allow improved access and control on the repaired line. An alternative repair would have required more extensive excavation, more components, and more time to achieve the same results and would have disrupted service while the repair was being executed.
